# The Barra Bridge – Assessment and Rehabilitation

## Abstract

## 1. Introduction

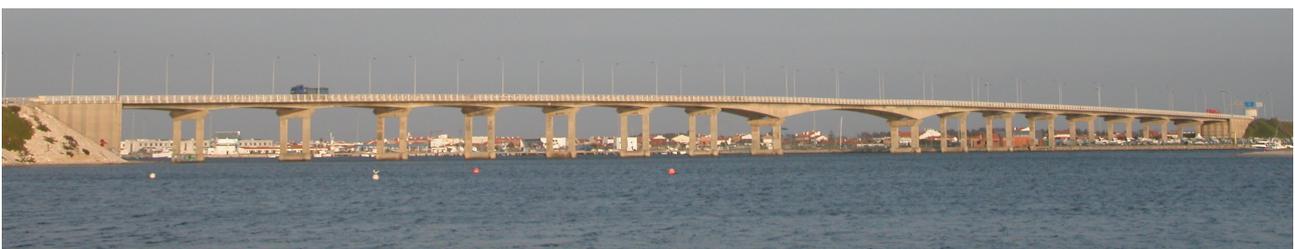
*Fig. 1 General view of the Barra Bridge*

The Barra Bridge has a total length of 578 meter, between abutments (*Fig. 1*). The central span has a length of 80 meter and the access viaducts, symmetrical to the central span, consist of a 25 meter long end span and 32 meter long current spans.

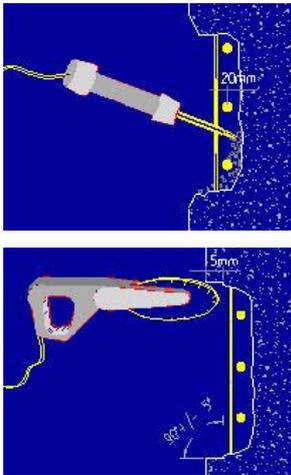
Fig. 2 An example of the procedures defined on the Project drawings

Such a relevant Project has imposed the development of very detailed drawings, regarding particularly the precise definition of the required specifications concerning the methods and the products to be applied (Fig. 2,3).

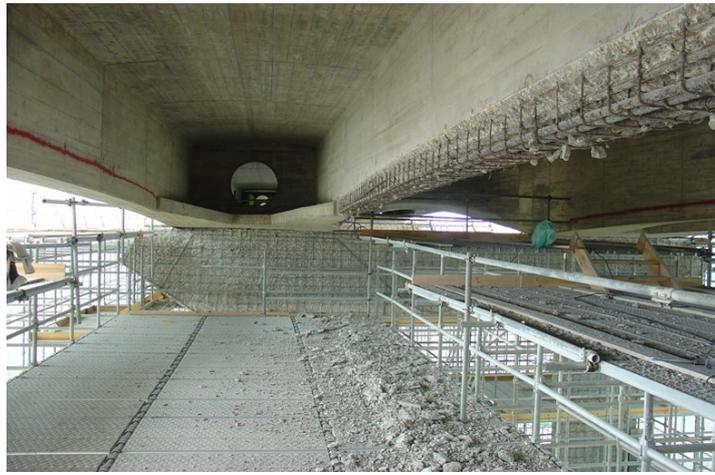
Fig. 3 An example of the translation of the Project requirements into the execution

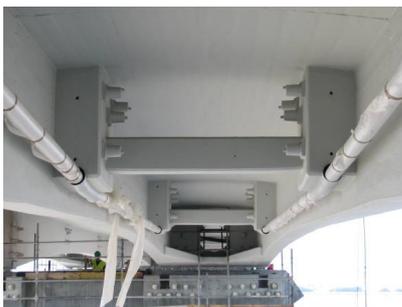
Fig. 4 External pre-stressing of the deck

The structural analysis revealed the need to proceed with a global and local strengthening of the structure. Various measures were adopted, such as the installation of external pre-stressing in the deck (Fig. 4) and in some piers, the piers strengthening with carbon fiber laminates, the strengthening of the box girders with structural steel (Fig. 5), the installation of viscous fluid dampers and other local strengthening solutions.

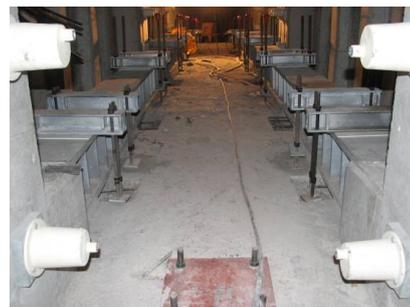
Fig. 5 Strengthened box girders' bottom slab
